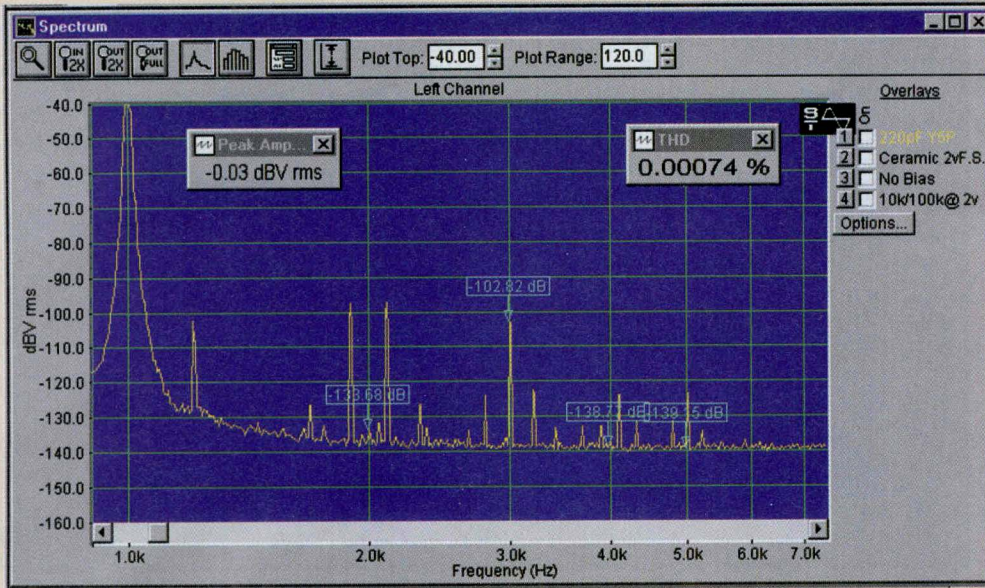
Figure 1: Y5P is a medium 'k' class 2 ceramic. Tested with two signals, 100Hz and 1kHz at 2 volts amplitude, with no bias network, it produces many new intermodulation distortion frequencies.
